The TWIN CESSNA *Flyer*

COST EFFECTIVE 310G PANEL UPGRADE

By Patrick Ripp, TTCT Member

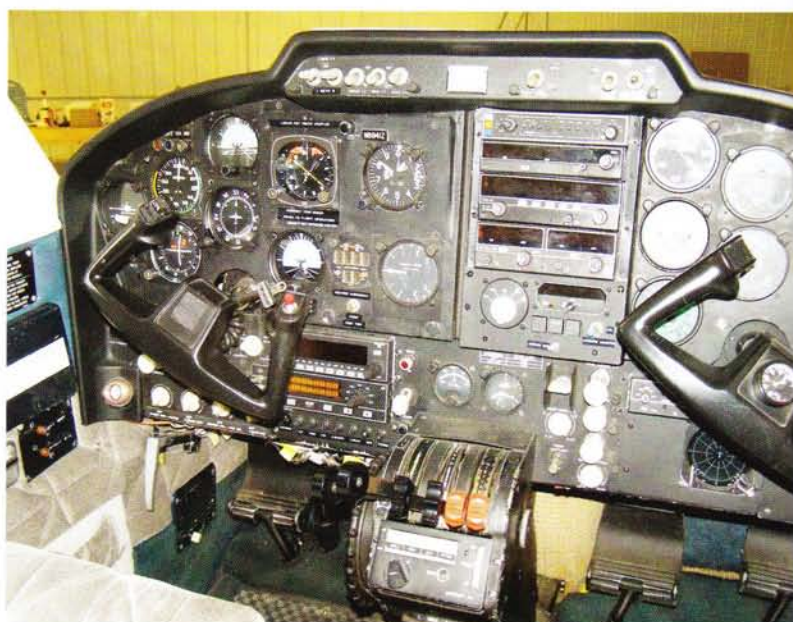
Original panel showing the hodgepodge arrangement of instruments, radios, switches and wiring hanging out from under the panel.

As you can see, the original panel was a 45-year hodgepodge of original equipment with various additions and modifications. There were radios and circuit breakers in various odd places, the Stormscope and EGT were off on the right and hard to see. My original plan was simply to take out the original left side panel and tidy it

up with a standard "T" arrangement. This was not to be. As I got behind the panel, I was shocked at the condition of the wiring, instrument plumbing and overall shabby avionics installations. I have seen a lot of bad panel "behinds" over the years, but this was an unsafe mess so I decided to start over completely.

Both original panels and the avionics rack were removed. All of the instrument plumbing was original hose dated 1961 and quite brittle. The panel lighting wiring was badly cut up so most of it was removed back to the buss bars in preparation for installation of "Nulite" light bezels. Many of the ground circuits were spliced and piggy backed in numerous places. Some wires had as many as 6 splices on them. All of the instrument, lighting and avionics ground circuits were replaced and run to a pair of buss bars on the forward bulkhead just forward of the control column. All of the avionics wiring was removed and "cleaned up" for reinstallation. Once the years of accumulated wiring modifications and repairs were removed, the basic original

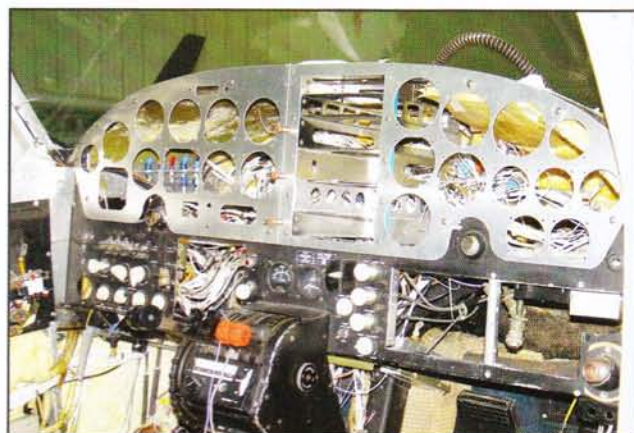
The wiring is mostly cleaned and up and in place. The new panel sections are temporarily installed along with the avionics racks.

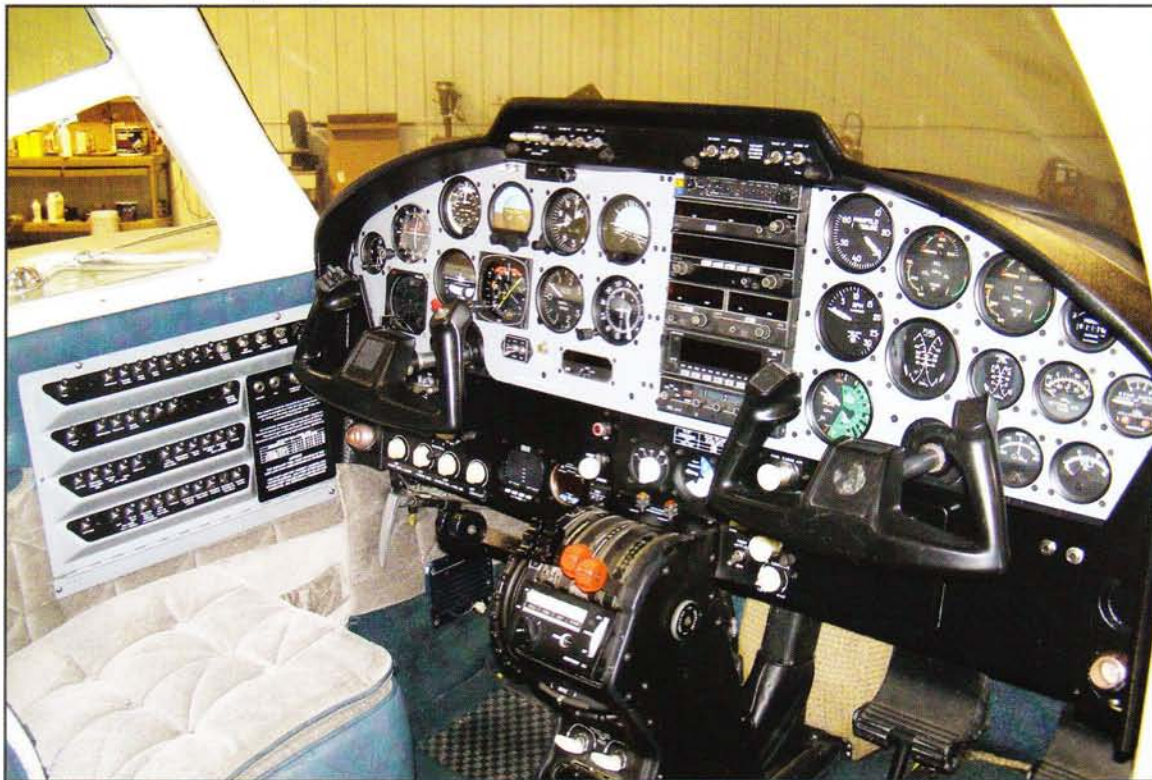
The new panel. This upgrade, plus a yoke-mounted Garmin 696, gives me some "glass-panel" capability at a fraction of the cost. These older radios are reliable and have plenty of life left in them.

The aircraft is now a joy to fly. Everything on the panel works and the layout makes sense. The gear lights are easy to see with LED's replacing the original lamps in the annunciator. This type of panel upgrade is a good alternative for owners that do not

want or need the new glass technology. Not being a hard IFR flyer, the older GPS and RNAV units will take me anywhere I need to go. I do use a yoke mounted 396 that gives me a good picture of where I am. I would like to swap out the KLN-89B for a KLN-94 at some time. The cost of doing the panel was not too bad in terms of dollars, but if I had to count my time it would be substantial. The 310 instrument face panels are not structural so they can be configured to anything an owner wants. There are only a few structural components behind the panel that need to be worked around. For a competent AP/owner or an owner that can work under supervision of a competent AP, this is a great way to upgrade your aircraft and really get to know how its systems.
